CZECH FIRE INVESTIGATORS ON FIRE

MINISTERSTVO VNITRA
Generální ředitelství
HASIČSKÉHO ZÁCHRANNÉHO SBORU
ČESKÉ REPUBLIKY

Table of contents

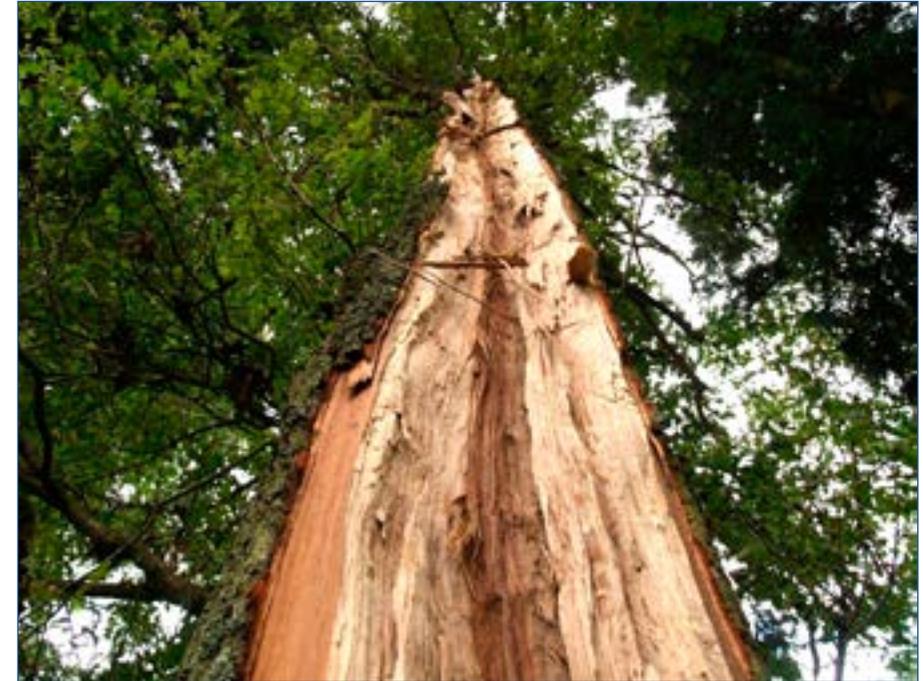
Cause of fire: Strike of a lightning into the tree crown and its current over the roots of trees and the power cable into the restaurant and guest house.

Figure 5 - One of the tree trunks that were damaged by lightning over the house.

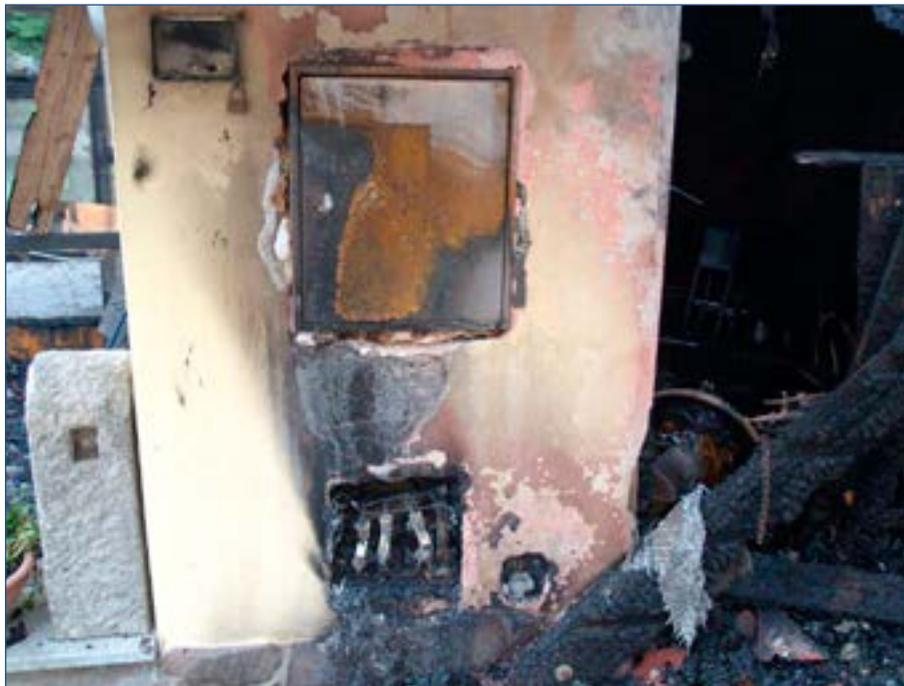
Figure 4 - Criminalistic outbreaks in the fuse box at the wooden stairs to the attic of the restaurant.

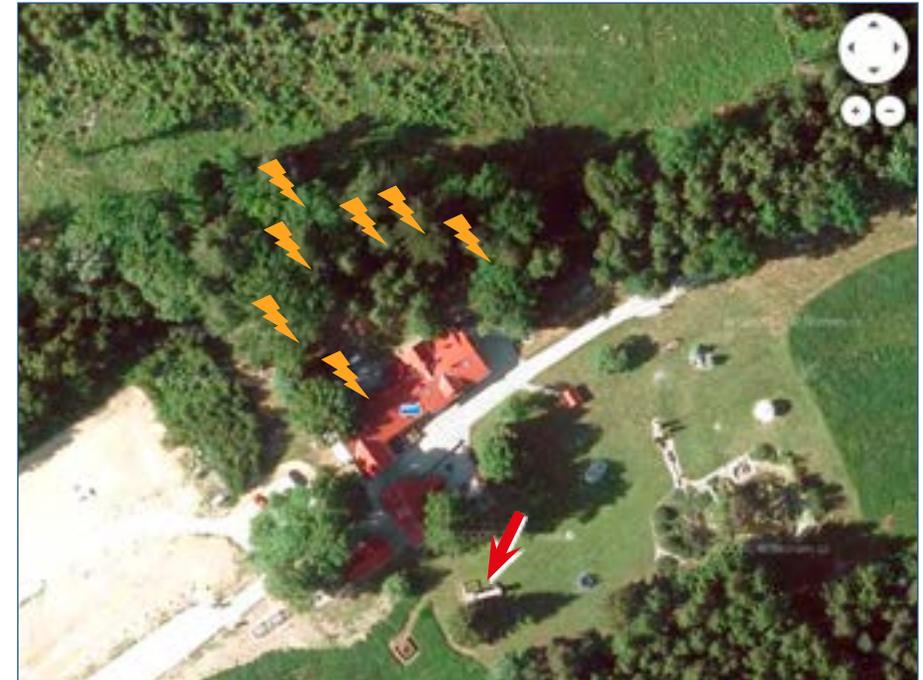
Figure 6 - Marked trees with lightning strikes and the likelihood of a lightning strike in the house.

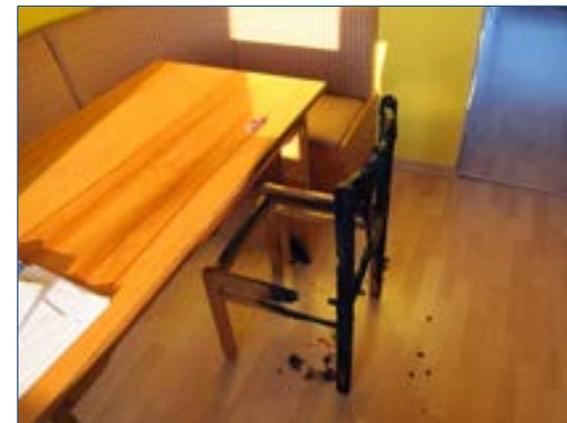
Figure 3 - View of the burned chair.

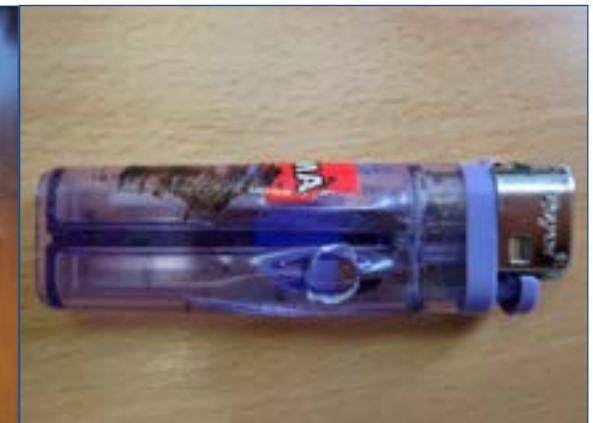
Cause of fire: Operational failure, static discharge - lighter explosion.

Figure 4 - Detailed view of gas lighter.

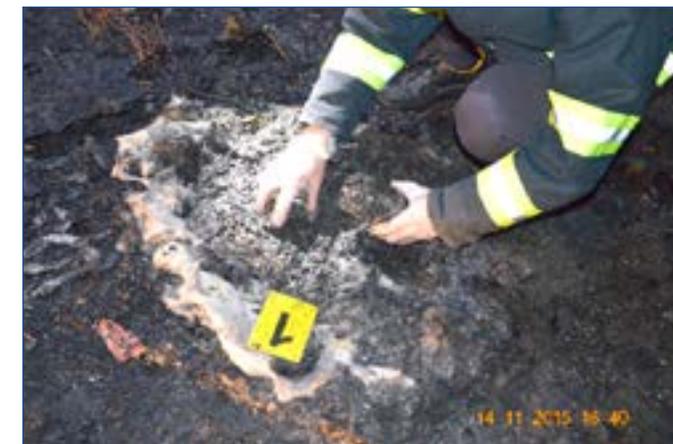
Place which was mostly damaged by combustion gases was found on the chassis of the vehicle. Specifically in the place behind the engine, under the driver's and the front passenger seat's. It was at this point that the fire was transferred to the vehicle. In order to exclude the possibility of a technical fault in the wiring of the vehicle, an expert in electrical engineering from PPI Lázně Bohdaneč was called to the site. No electrical markers that would indicate a technical fault on the wiring of the vehicle have been found. At the time of uncovered fire under the vehicle, approximately two hours after fire was observed, the fire temperature measured by the thermal camera of the professional fire protection unit ranged from 17 to 22 ° C. The ambient temperature of the ground was measured at 4 °C. The open fireplace was covered by loose insulation residues on the chassis of the vehicle.

Figure 5 - Remnants of the fireplace under the vehicle, covered by vehicle insulation.

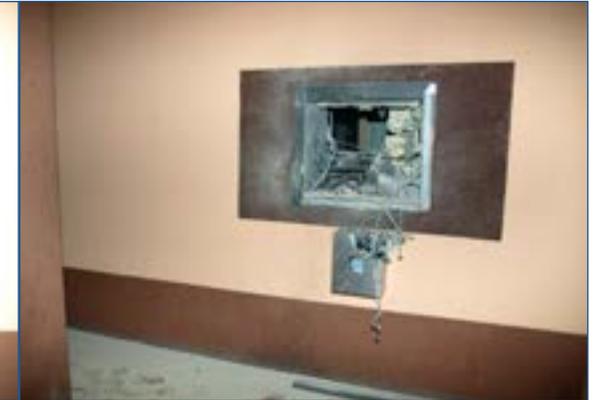
Figure 2 - View of a damaged ATM.

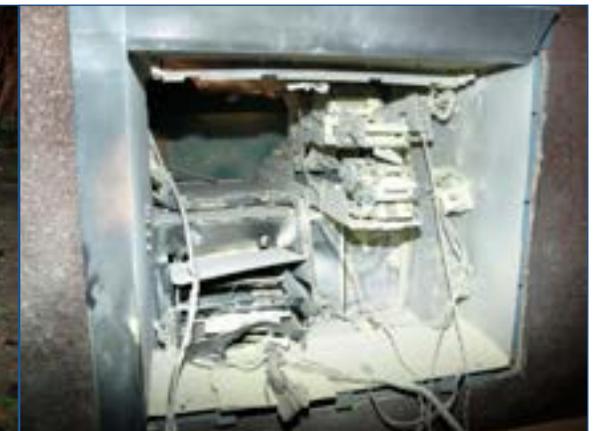
Figure 4 - View of the internal damaged part of the ATM.

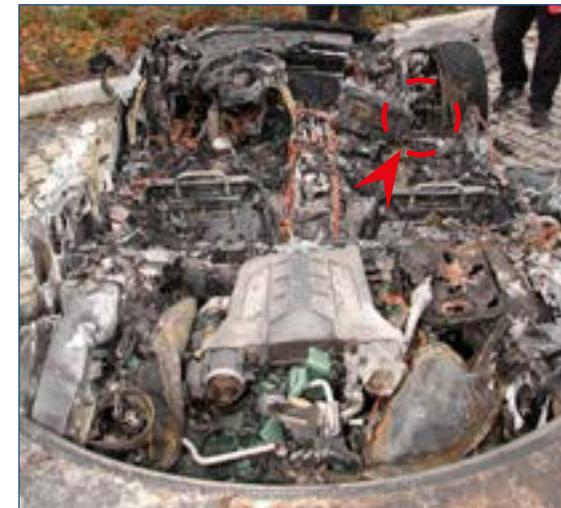
The fire of the vehicle was caused by a technical failure of the wiring on an unprotected (without overcurrent / short circuit protection) high-current cable (single-core copper rope) that brings potential from the positive pole of the battery to the electrical wiring rail. Two branches with a mutual electric potential (12 V) were undesirable connected due to the mechanical damage of the cable insulation where the cable pass through the aluminum body of the vehicle.

Figure 3 - Interior view on the Audi R8 Torus with marked outbreak where the power cable insulation has been damaged.

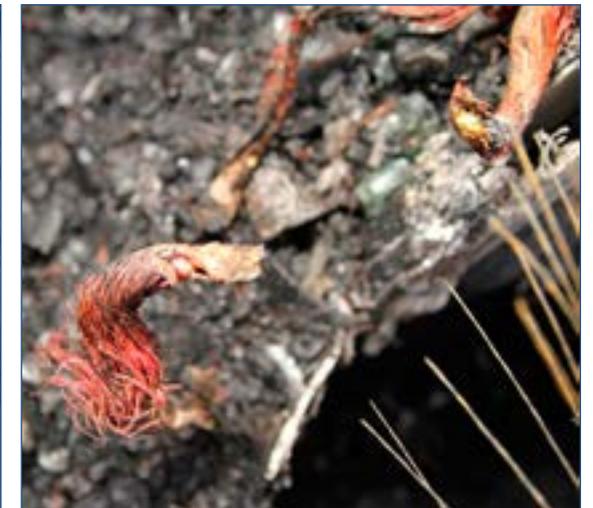
Figure 4 - View of the pearls in the form of Copper nozzles and thermal break of the cable core.

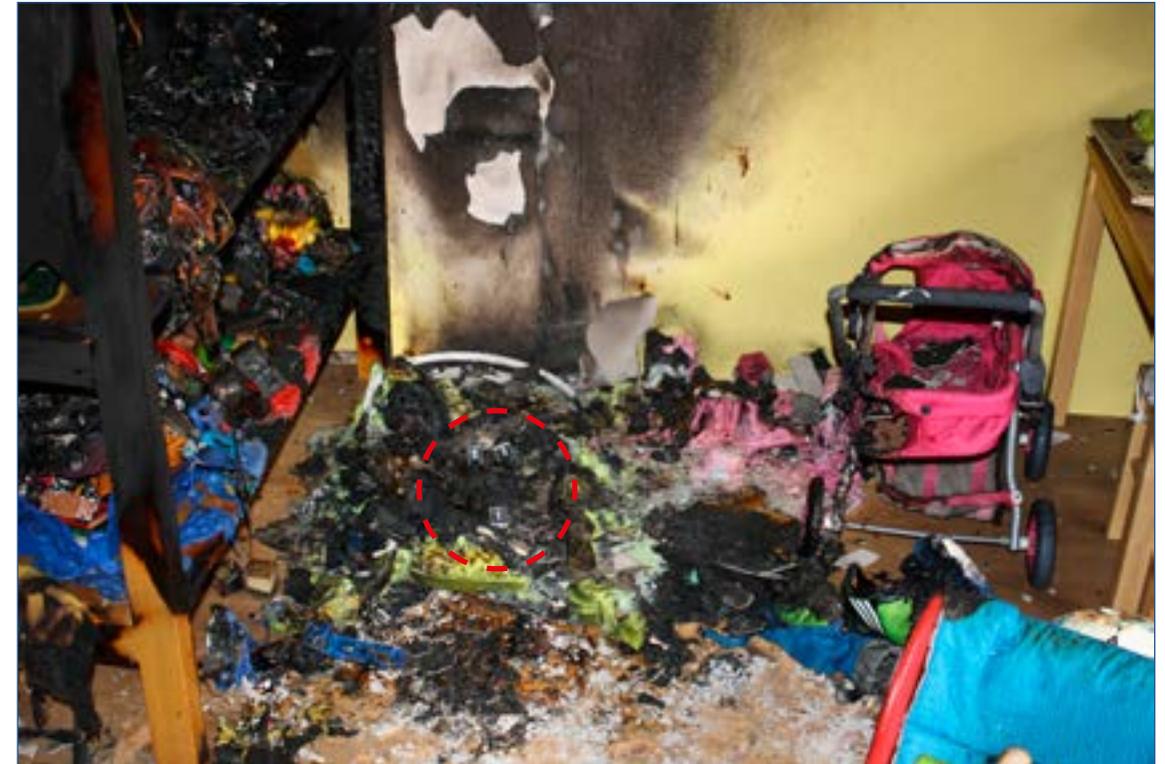
Cause of fire: Technical fault on the lithium battery placed inside the Chou Chou doll

Figure 1 – A view on the fire scene with marked criminalistic focus.

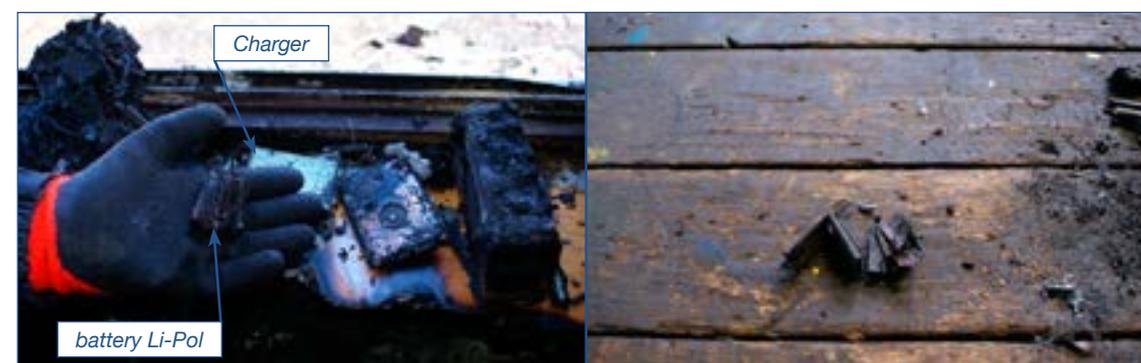
During the investigation of the point of origin of the fire there was found charger and battery. On the battery (three-element) was one cell torn.

Figure 5 – Charger and battery.

Figure 6 – Battery with broken cell.

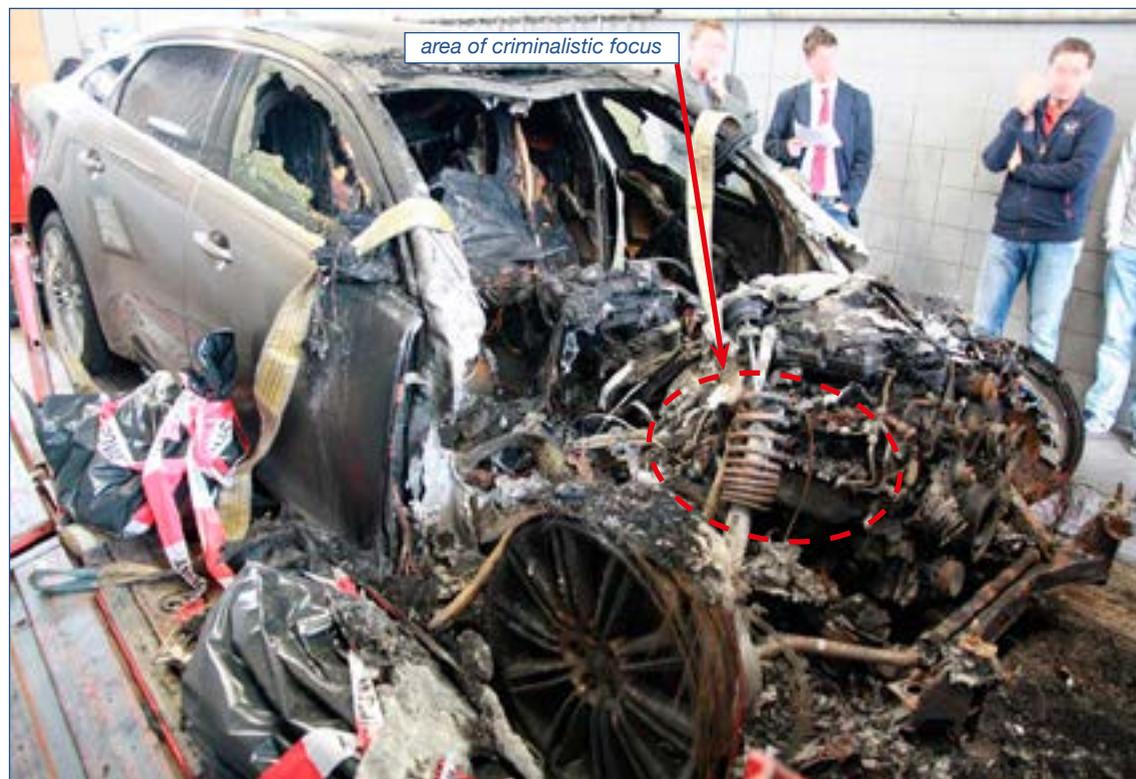
Cause of fire: Leaked oil and subsequent ignition of oil vapours mixed with air from surface temperatures of the exhaust gas collector.

Figure 1 - View of criminalistic focus.

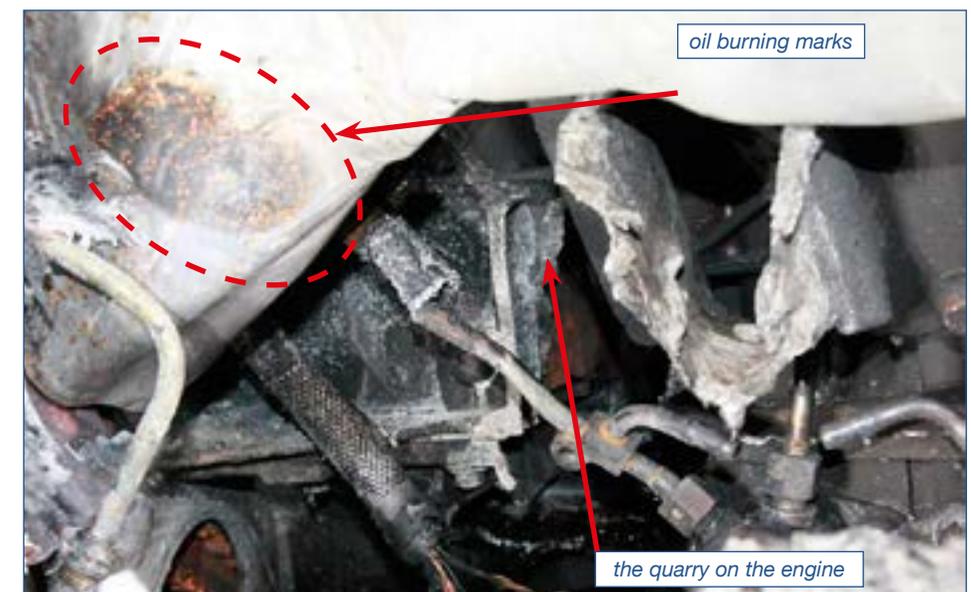
Figure 3 - View of the engine block and exhaust gas collector.

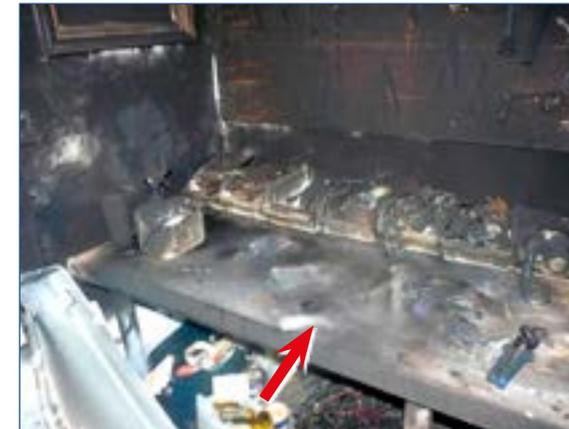
Fire investigator looked at the desk and found two used electrodes, pliers, gloves and a meter. On the desk he also found traces, that testified presence of some objects at the time of the fire but afterwards they have been removed away. According to the owner's announcement there was nothing else on the ground and he did not move anything after the fire. He also stated, that electrodes were in place for a long time because he sold the welding aggregate about a year ago.

Figure 2 - Traces after objects.

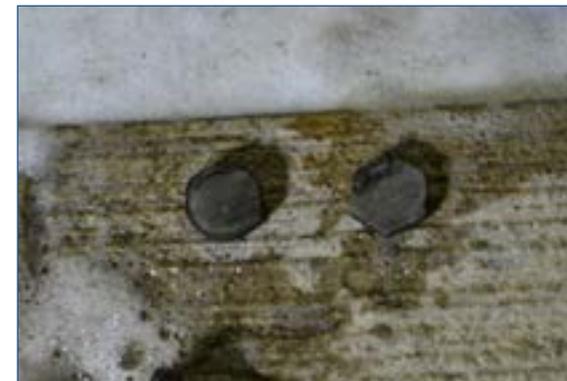
Figure 5 - Detail view on a screw which was found in a shaft.

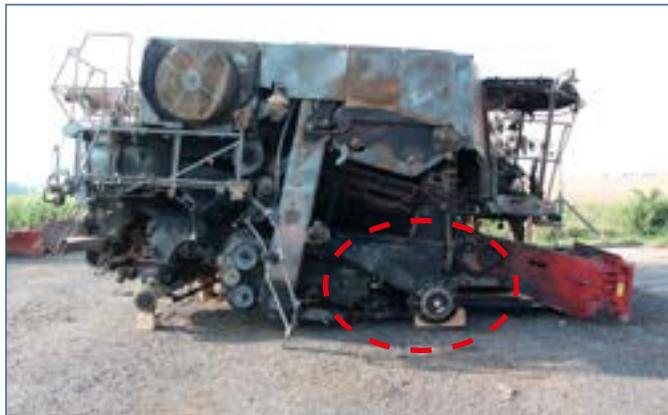
The fire of the harvester was caused due to overloading / blocking of the balancing system of the sieve box (shaking). The barrier created a braking force blocking the smooth operation of the electric motor and did not allow sufficient conversion of electrical energy into mechanical work. The resulting “ohm losses” in the rotor winding caused emission of the “Joule’s heat” to the enclosed space. Cumulative heat generation led into rise of temperature. The heating of the system negatively affected the thermal degradation of the insulating layer of the winding conductor, creating inter-screw short circuits with a higher flow of electric current (proportionally rised the total heat radiated). The whole process consequently graduated into the initiation of burning of the surrounding plastic components and accumulated dirt from grain process. Blocking the balancing system of the sieve box has resulted from an unspecified rigid barrier that hinders the movement of the horizontal plate (such as stone, rock or dirt).

Figure 1 – Case 9230 harvester with marked criminalistics focus.

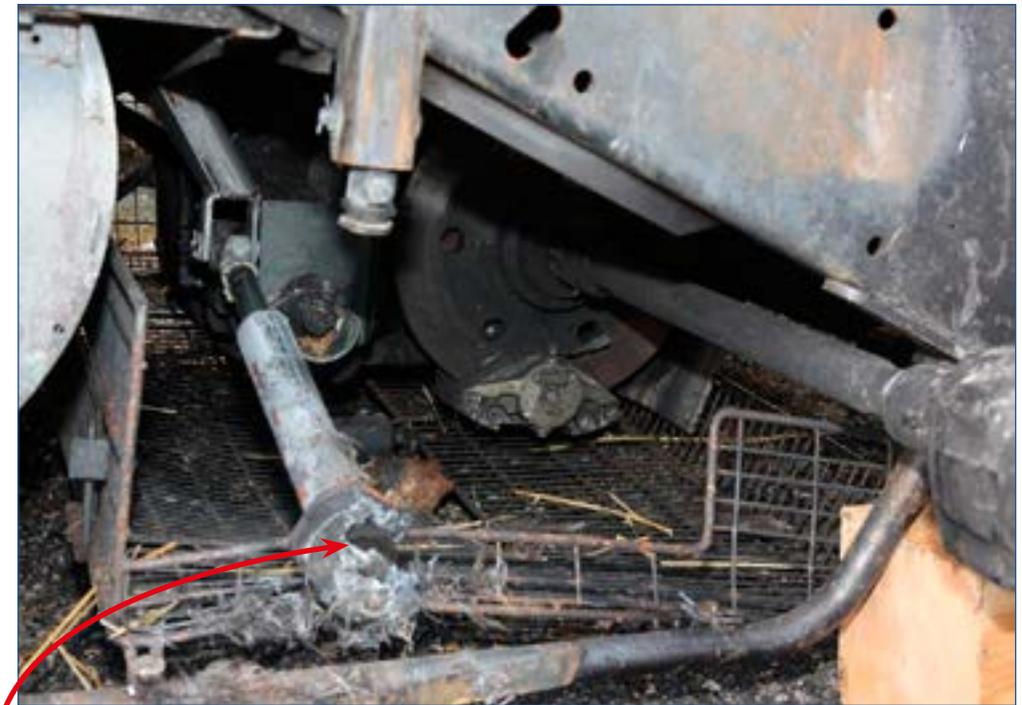
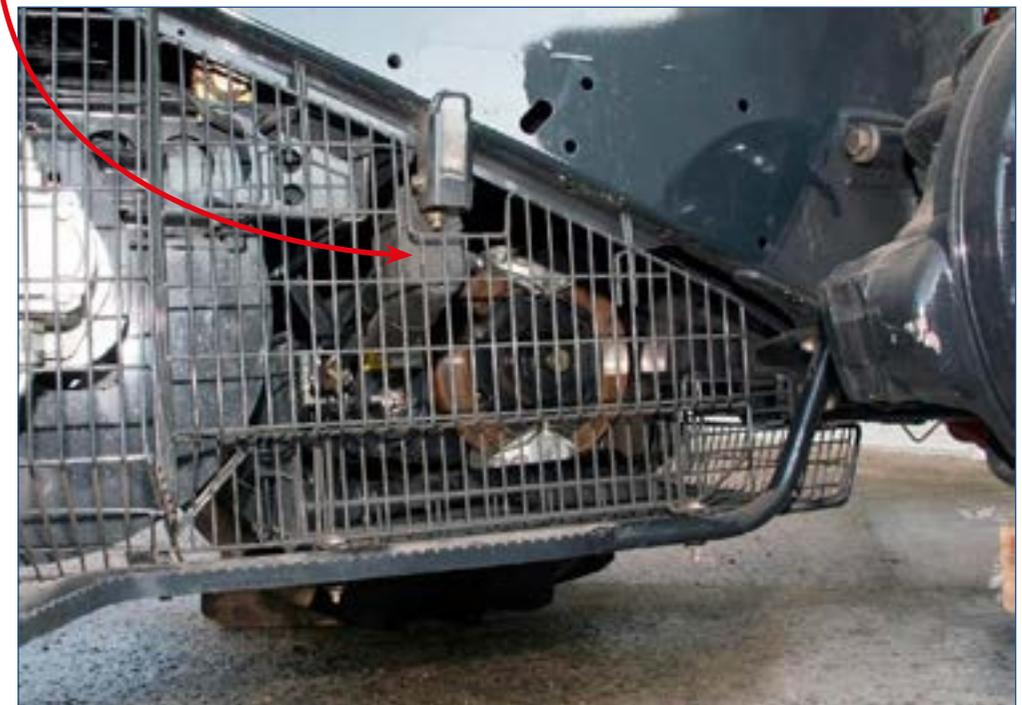
Figure 3, 4 – Comparison of damaged and undamaged electromechanical system of harvesters sieve box.

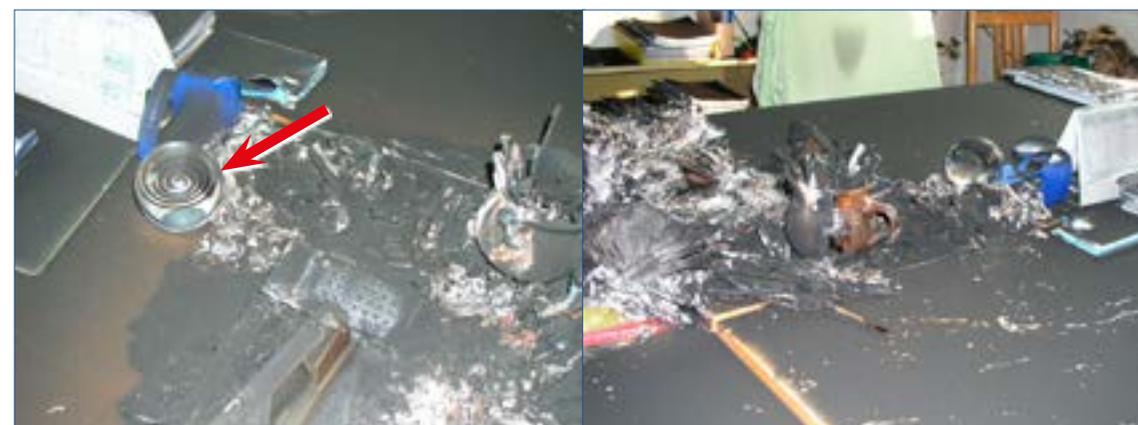
Figure 3 – Detailed picture of transparent glass ball. Figure 4 – Detailed picture of a back side of a table.

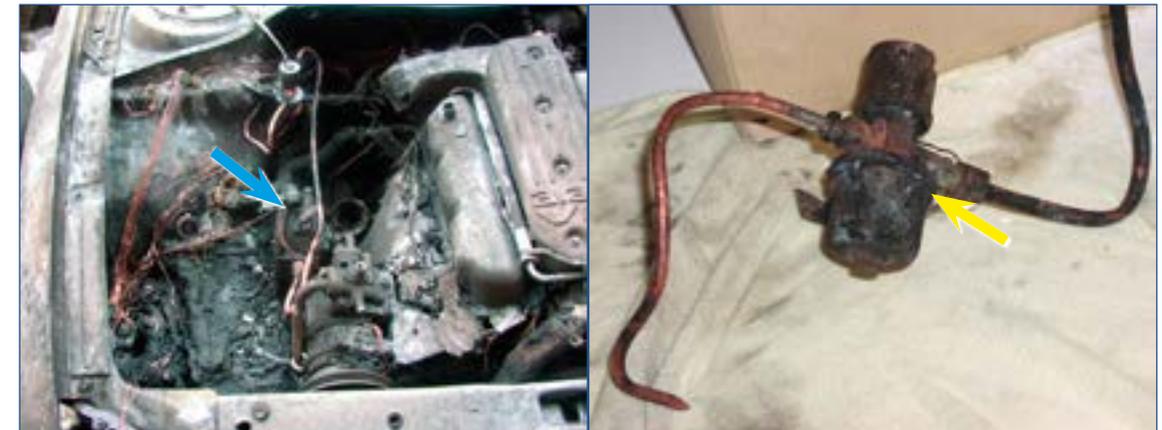
Figure 2 – Car engine - solenoid valve (blue arrow).

Figure 3 – Place of the gas leak - fitting of the solenoid valve.

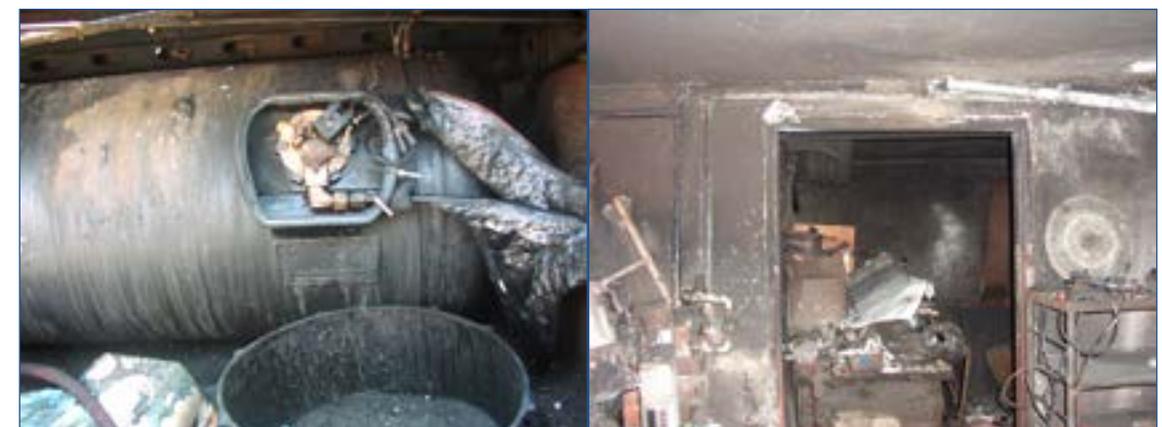
In this case, the gas leakage occurred also due to a malfunction of the shut-off cylinder valve. It was caused by impurities and neglect of maintenance. The shut-off cylinder valve is controlled by solenoid valve and it should have been closed because the car was not in operation. Therefore when the user loosed the fitting of a solenoid valve the gas could leak.

Figure 4 – Shut-off cylinder valve.

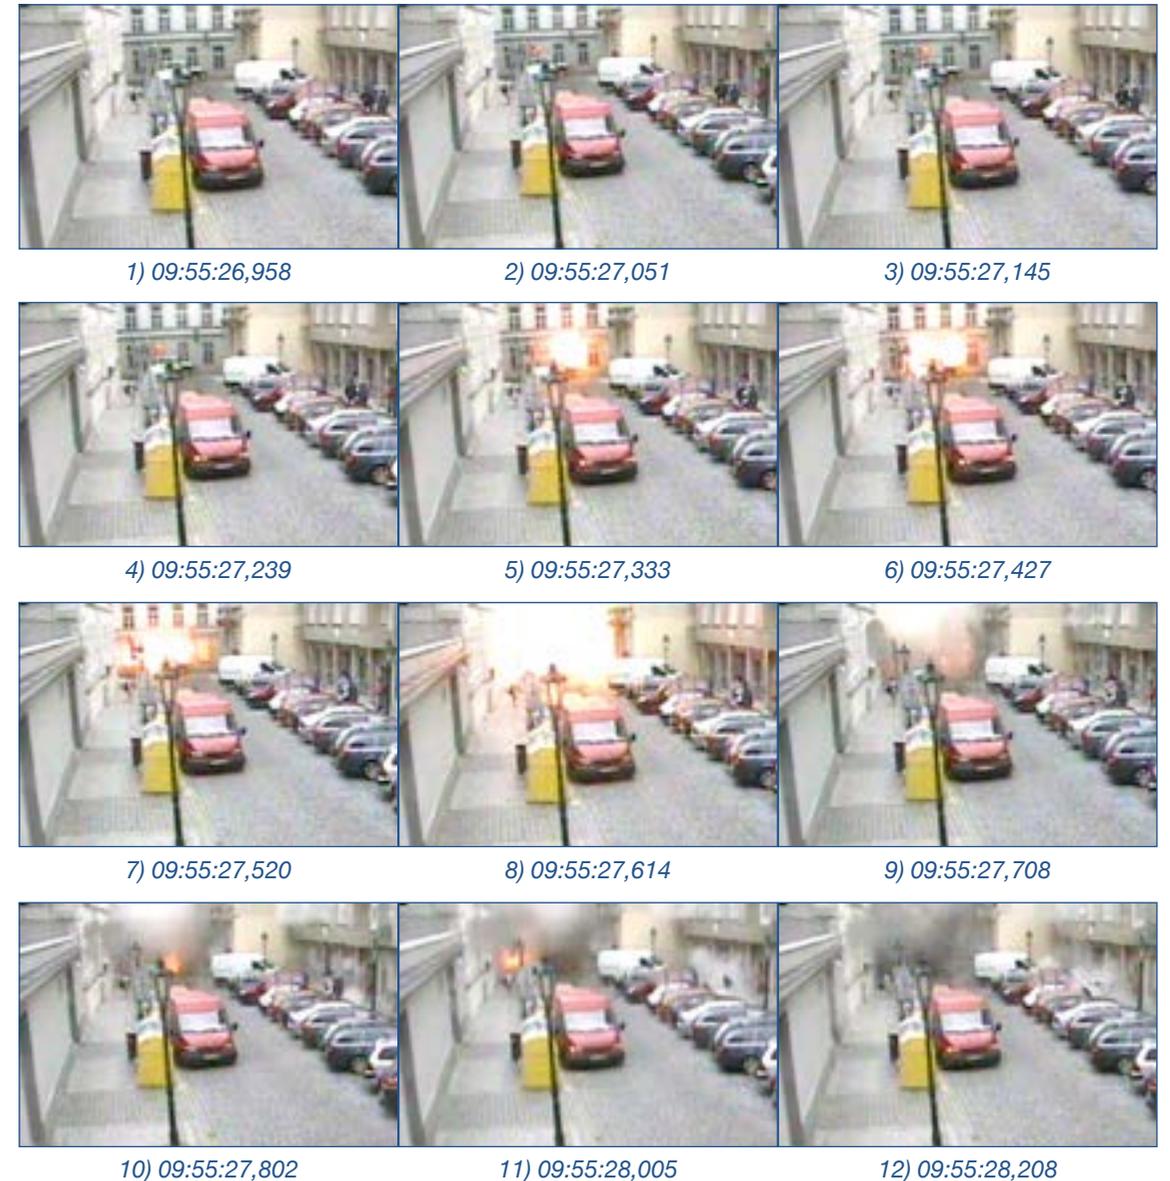
The investigation revealed that during the laying of the gas pipeline between the years 1977 and 1978, the construction process did not follow the approved project documentation and it was contrary to the valid regulations. The gas pipeline was placed directly on the underground tramway traction wire, without the required distance or concrete protector. Considering the fact that the responsible construction manager died long before the event occurred, the case was postponed. CCTV record significantly helped the investigators to clarify the situation before and after the explosion, especially the original location, time, and course of the explosion.

Figure s (1. – 12.) – CCTV record – course of the explosion

1) normal condition; 2) place of initiation; 3) preparing of explosive mixture; 4) preparing of explosive mixture; 5) explosion and pressure increase; 6) explosion and pressure increase; 7) explosion and pressure increase; 8) explosion and pressure increase (maximum); 9) secondary explosions (gas accumulated in the drain in front of the building); 10) secondary explosions (gas accumulated in the drain in front of the building); 11) moving of CCTV camera caused by pressure wave; 12) end of explosion

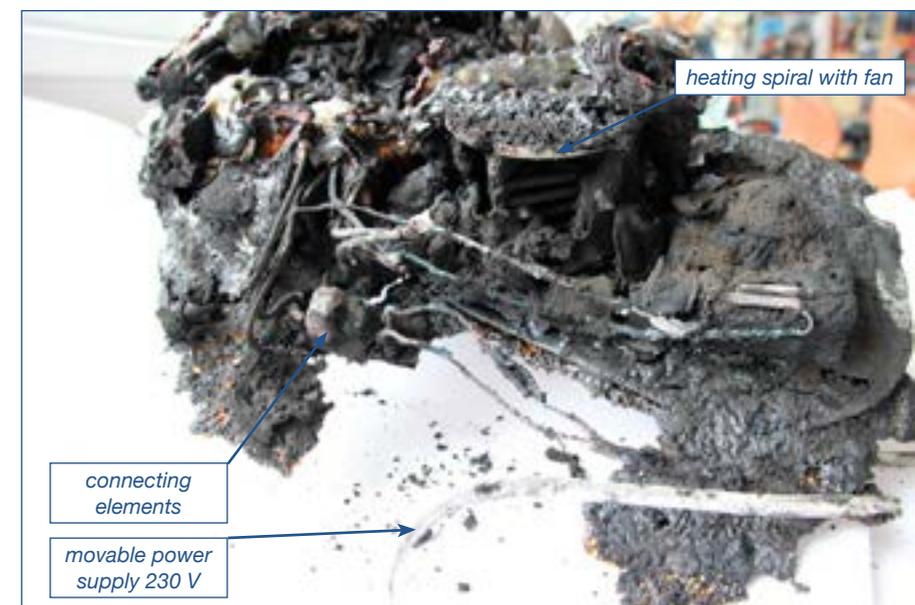
Figure 3 - The point of origin on the base unit of the fruit dryer.

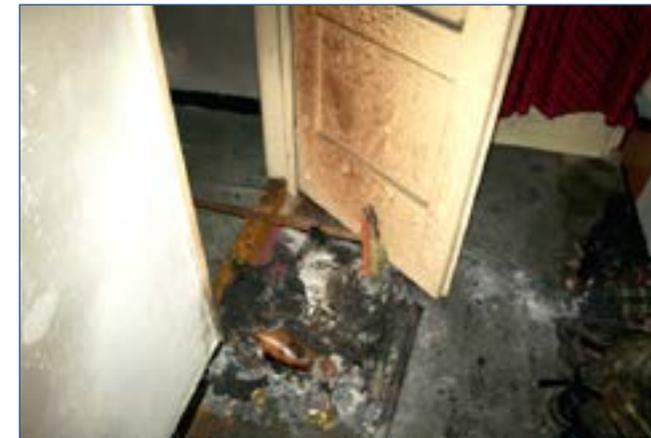
Figure 2 - Point of origin - burned vacuum cleaner in front of the toilet door.

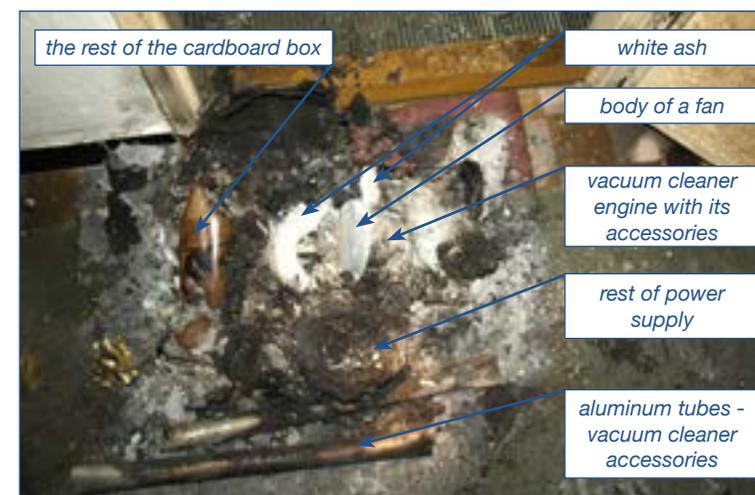
Figure 3 - Point of origin - detail.
