CZECH FIRE INVESTIGATORS ON FIRE

MINISTERSTVO VNITRA
Generální ředitelství
HASIČSKÉHO ZÁCHRANNÉHO SBORU
ČESKÉ REPUBLIKY

Table of contents

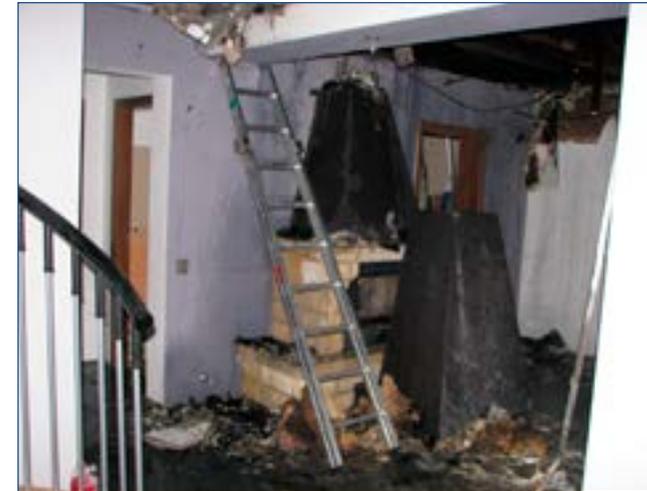
On the basis of the above mentioned facts, it was possible to state that due to the radiant heat and contact of the hot surface of the hot air exchanger, which reached temperatures of 450 to 675 °C, with a wooden ceiling structure, the heat transfer through the radiation and the conduction into the combustible part of the structure, the closed space and the ignition of the wooden structure, whose ignition temperature is 397 °C, the self-ignition temperature of 120 °C.

Figure 1 - Heater housing with double-walled hot air coil.

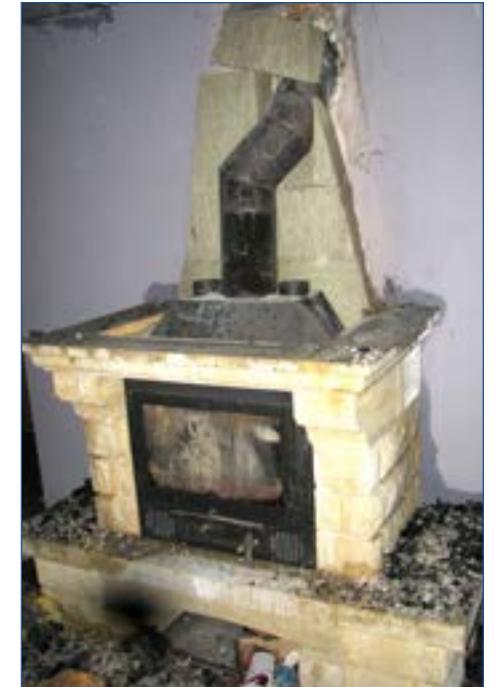
The GIM 3090-MX 4 Infiacometer (type of contactless thermometer) and the Argus e2v thermocouple were used for measuring temperatures. In this investigation, the temperature ranges data were found on the sur-

Figure 2 - Temperature flow at the top of the heat exchanger flange.

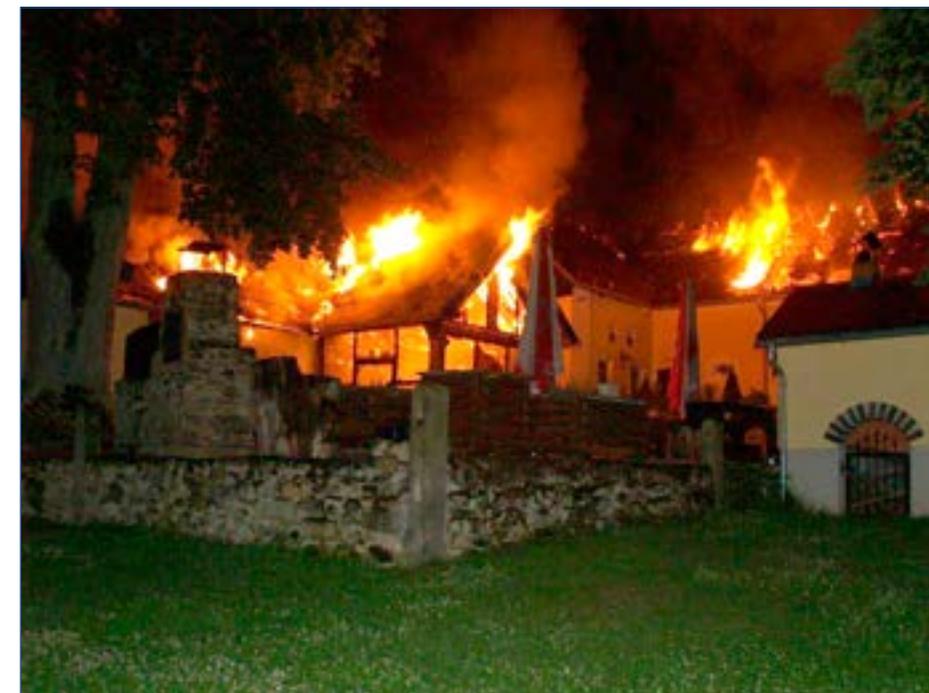
Figure 2 - The objects in a fire.

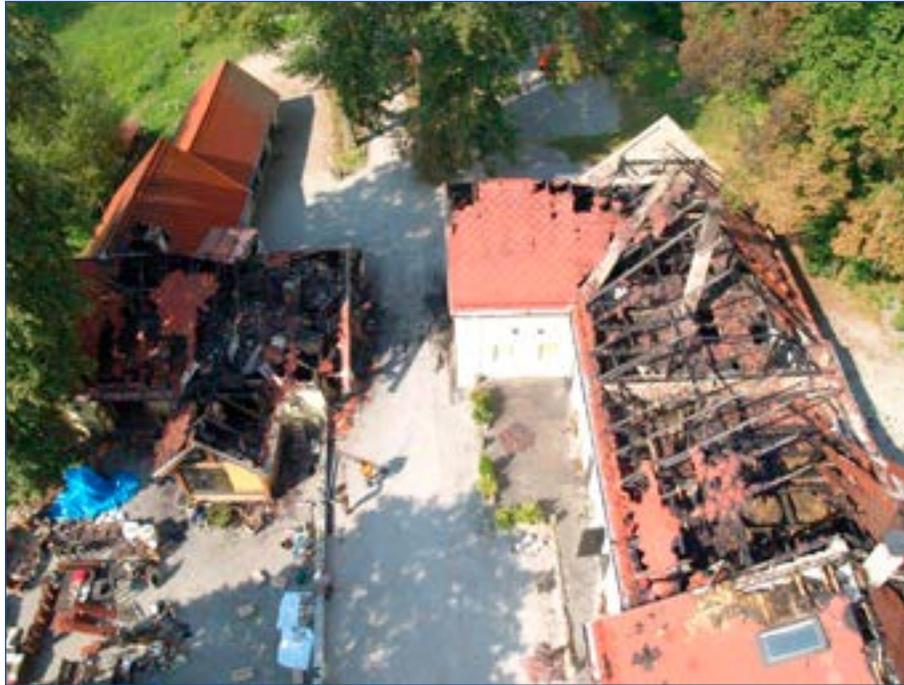
Figure 3 - Height of a fire.

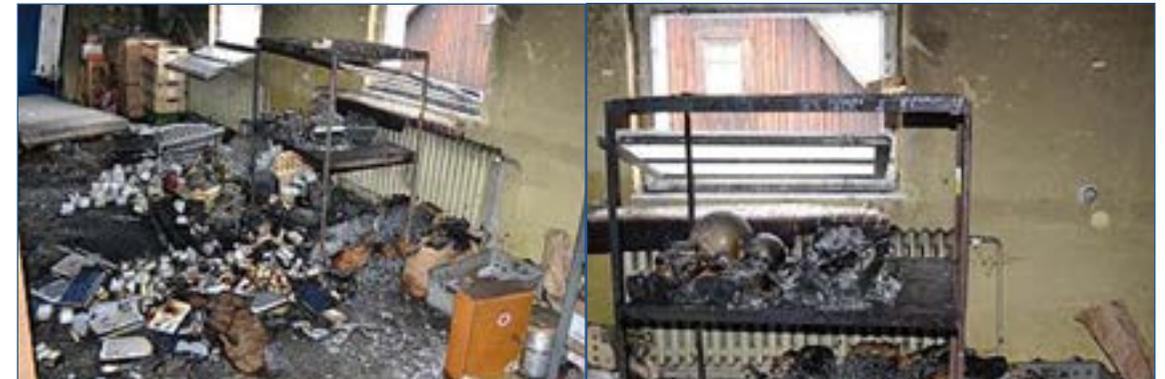
Figure 3 - Criminalistic and Fire Outbreaks.

Figure 4 - Balls shelf.

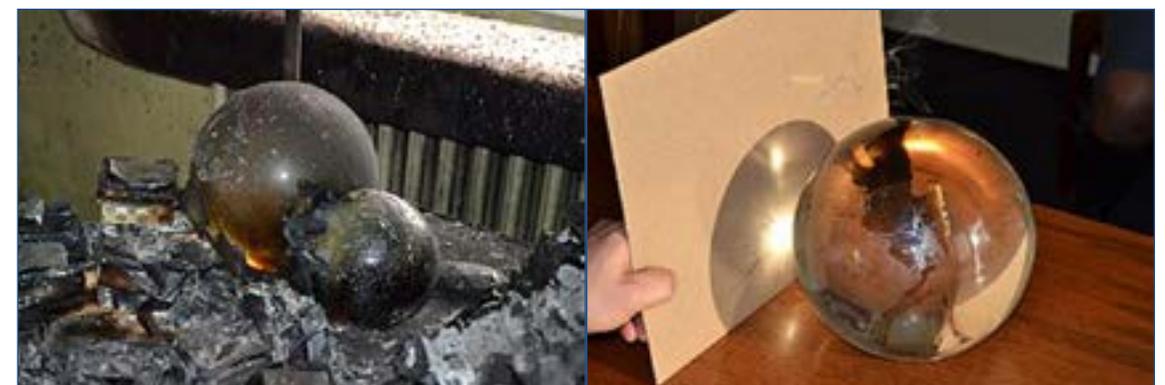
Following the experiment, it was found that the sphere created an optical focus of concentrated solar rays about 5 cm behind the surface of this sphere. In this focal point, the temperature was high enough to be able to ignite the carton. Another feature of the ball, unlike the classic magnifying glass, is that the focus does not deform in the sun's motion and is still effective. It was found and documented that it was at the time of the fire that the rack with the spheres and the boxes were fully illuminated by the sun, and that the sun was shining in the area between 08:00 and 09:00.

Figure 5 - Glass balls after a fire.

Figure 6 - Glass ball at the attempt, November, more than three meters from the window.

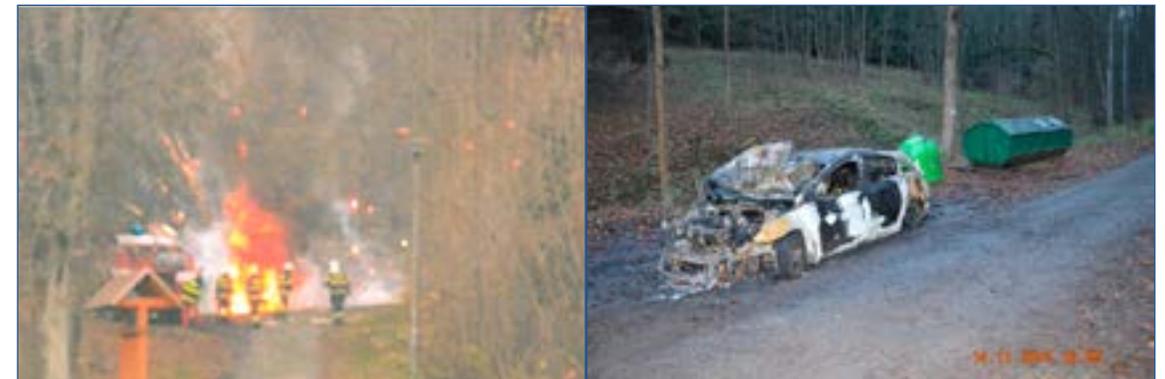
Place which was mostly damaged by combustion gases was found on the chassis of the vehicle. Specifically in the place behind the engine, under the driver's and the front passenger seat's. It was at this point that the fire was transferred to the vehicle. In order to exclude the possibility of a technical fault in the wiring of the vehicle, an expert in electrical engineering from PPI Lázně Bohdaneč was called to the site. No electrical markers that would indicate a technical fault on the wiring of the vehicle have been found. At the time of uncovered fire under the vehicle, approximately two hours after fire was observed, the fire temperature measured by the thermal camera of the professional fire protection unit ranged from 17 to 22 ° C. The ambient temperature of the ground was measured at 4 °C. The open fireplace was covered by loose insulation residues on the chassis of the vehicle.

Figure 3 - Shooting flares from the rear part of the vehicle.

Figure 4 - Vehicle condition after fire.

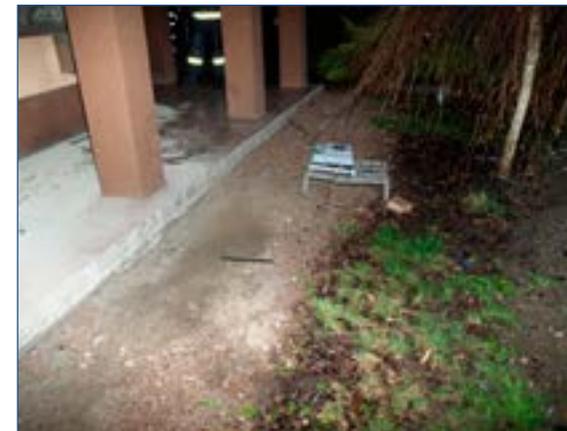
Figure 3 - View of the discarded front of the ATM.

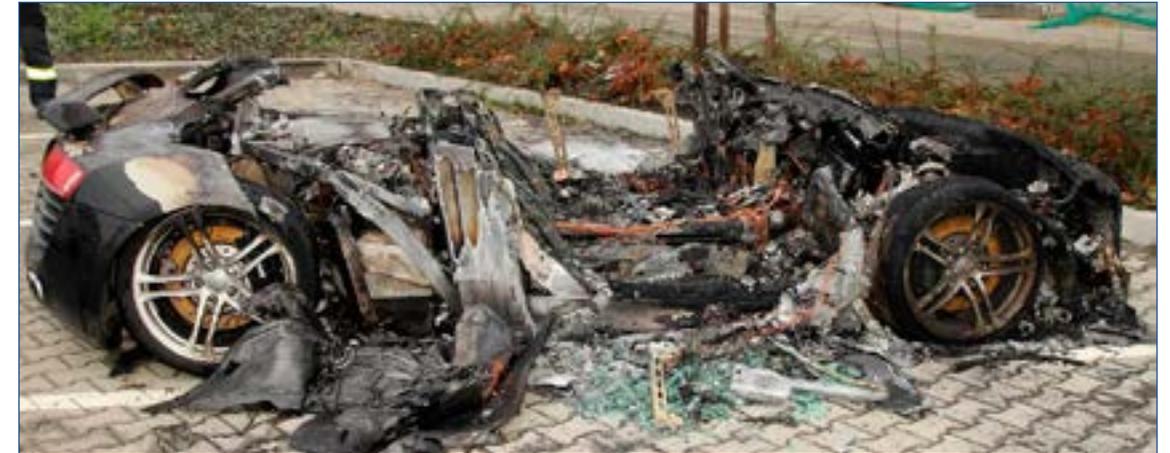
Figure 2 - Audi R8 after a fire.

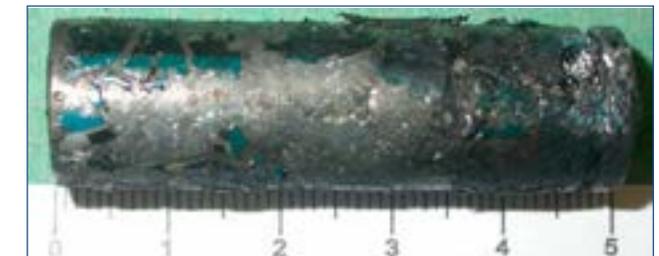
The investigators found damaged pieces of three lithium batteries inside the torso of the doll. Before the fire started, the Chou Chou doll contained a water container for imitating the tears. Before the inserting the lithium batteries inside the doll, the batteries were already used in photographic cameras and they were slightly surface-damaged.

Figure 3 - Battery which was removed from the doll.

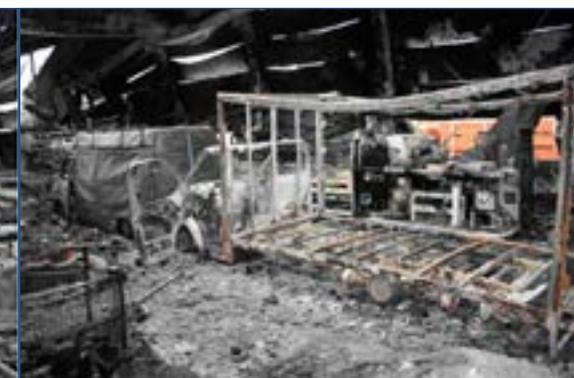
Figure 5 - Burned technology and parked vehicles.

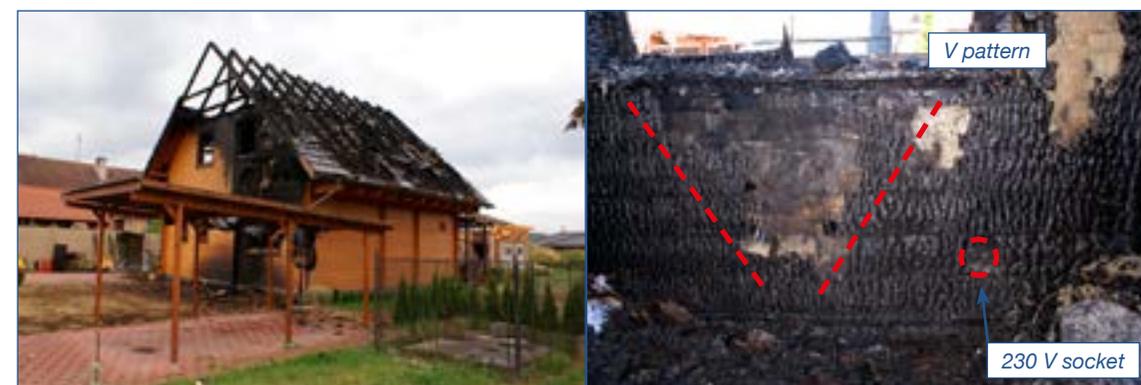
During the investigation of the point of origin of the fire there was found charger and battery. On the battery (three-element) was one cell torn.

Figure 4 – Point of origin.

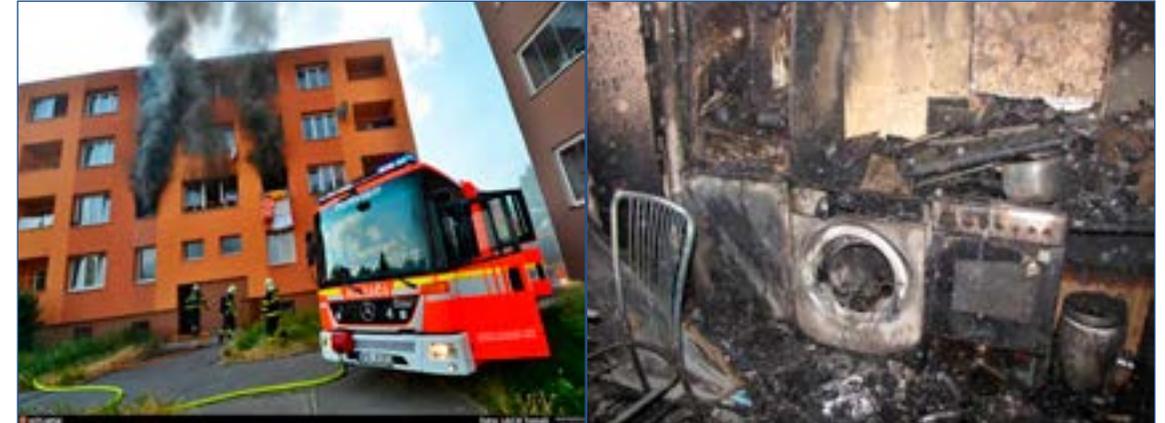
Figure 1 – Damaged house.

Figure 2 – View of the stove.

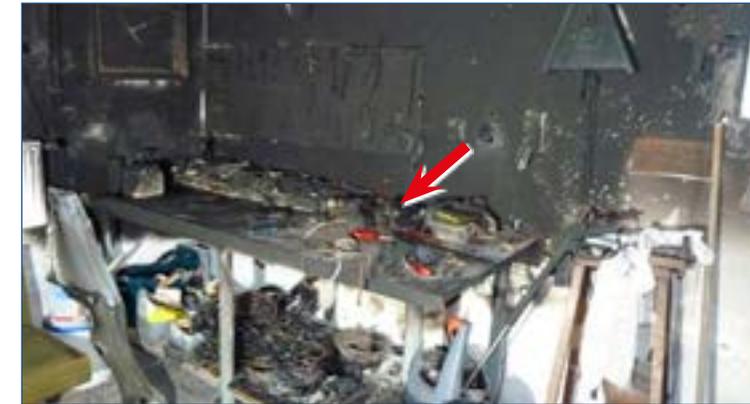
Figure 1 - Damaged workroom.

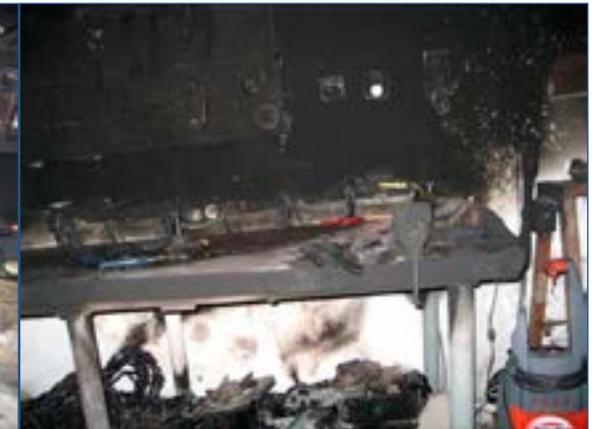
During the whole fire investigation the owner denied that he was welding in the workroom before the fire. Although the traces found were evidence of the opposite. He confessed after recovering the data from the camera's memory card. The Figures showed that a plug (welding machine) was plugged in the 230 V socket, because the socket was not smoked. When the fire investigator examined the socket, it was already smoked, this fact indicated the manipulating with the socket after the fire. Based on the submitted photo documentation, the owner of the house admitted that he had welded himself in the workroom and deliberately damaged socket with a candle flame and waxed with a wax.

Figure 3 - Socket just after the fire.

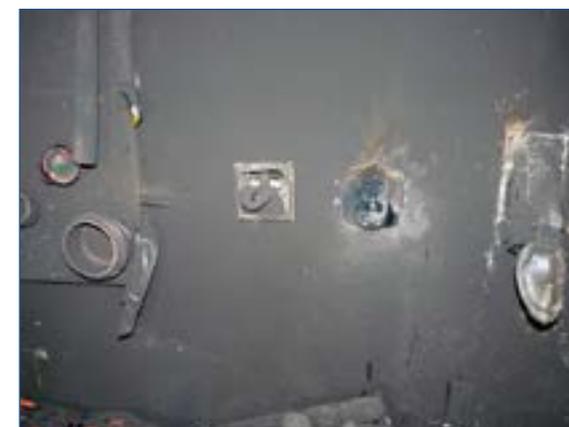
Figure 4 - Socket during examining by fire investigator.

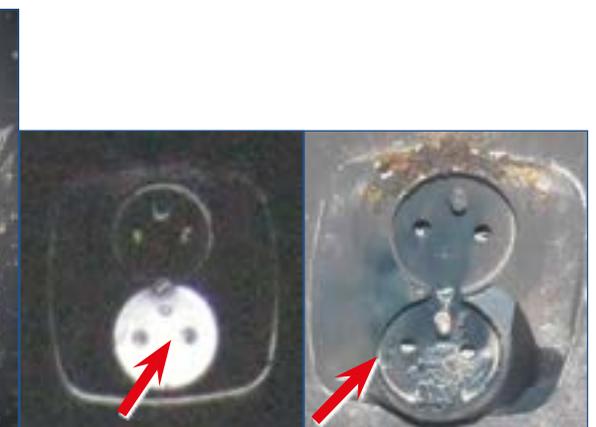
Figure 5 - Detail of socket immediately after the fire and during examination by fire investigator.

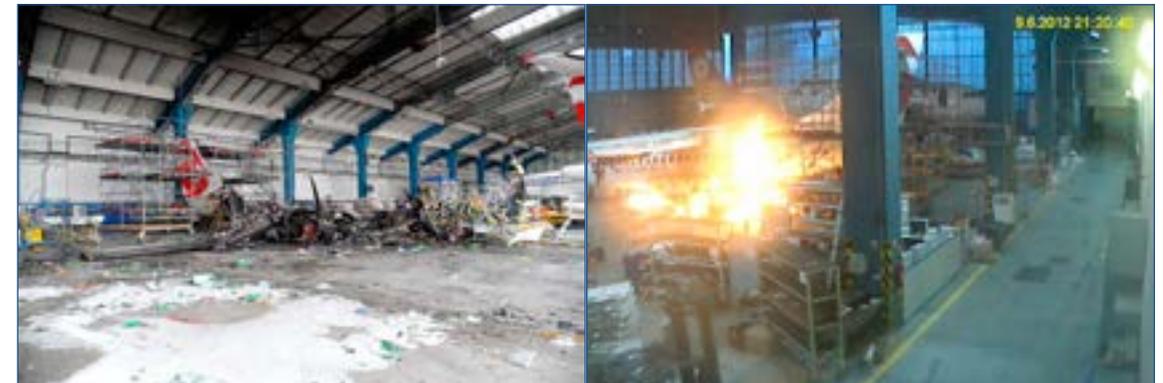
Figure 2 - Consequences of explosion in front part of an airplane. Figure 3 - Photo from camera recording of an airplane.

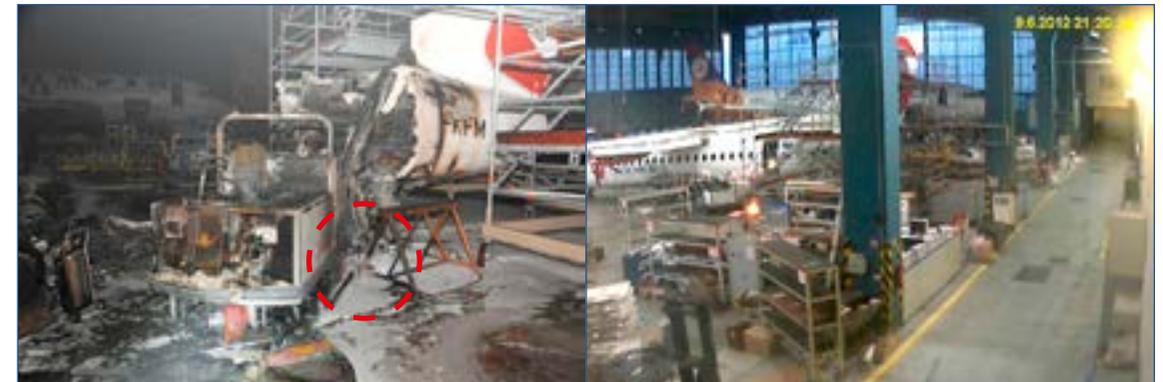
Figure 4 - Criminalistics focus.

Figure 5 - Area of ignition.

Cause of fire: Breach of working procedures when working in explosive atmospheres - use of angle grinder.

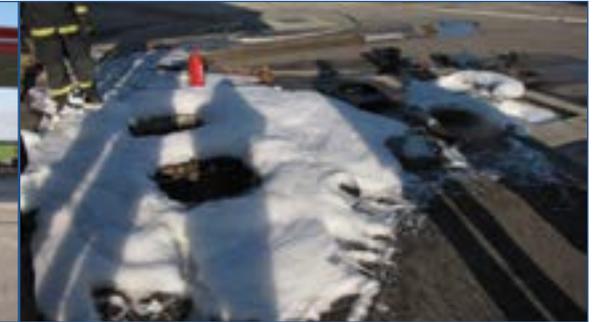
The fire started in the afternoon at a time when work was being carried out inside the fuel tanks leading to replace the tanks (disassembling of flanges and connecting fittings). The Point of origin was located in the Tank named „F“ where the flange of the tank was being dismantled. Inside the tanks were found traces of metallic materials, which were separated by the method of material removal (cutting, grinding,...). In addition, tools found on place were inappropriate for a work in explosive environments. There were used electric tools and people were not wearing antistatic work clothes. Employees used their own work clothes and tools without the employer's consciousness.

Figure 2 – Working place.

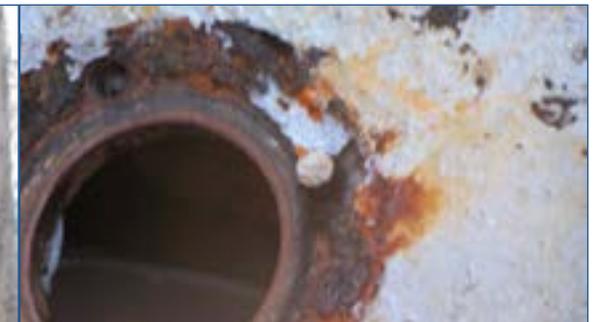
After an explosion when a worker using an angle grinder inside the tank was killed the co-workers removed the electric tools from the fire scene. Employees consistently alleged that they did not know about the using of such a tool, although it was clear from the CCTV record that they brought the angle grinder to the inside of the tank and also they used it.

Figure 4 – Detail view on a screw which was grinded by angle grinder.

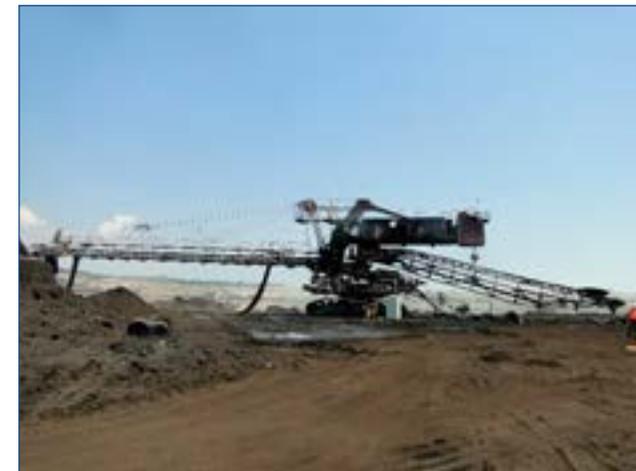
Figure 2 – View on the subject after a fire.

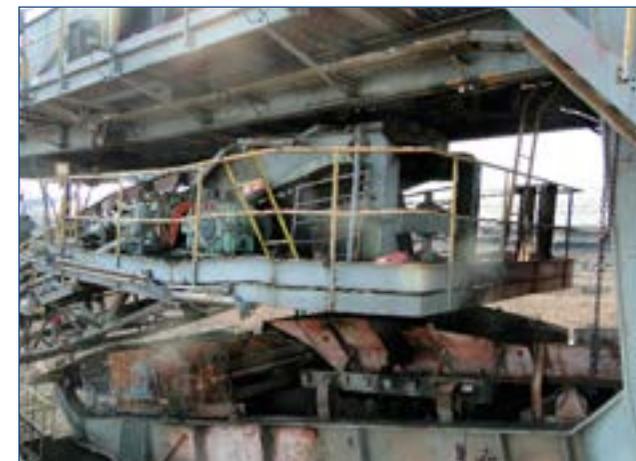
Cause of fire: Breach of fire safety conditions when doing a work with open fire - burning and welding of metals.

The fire was spotted in the evening when burning took place in the central part of the tracked vehicle and gradually spread to other technological parts of the vehicle. The fire started at place where the burning and welding work was carried out on a tracked vehicle in the time of dry weather at an outside temperature of 26 ° C to 30 ° C and the east wind speed of 2 to 6 m/s.

Figure 3 – Point of origin.

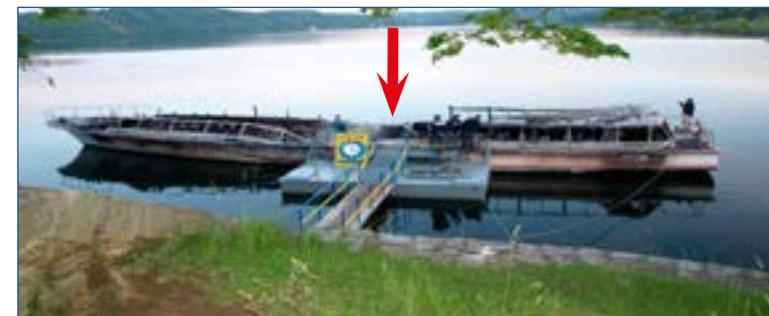
The fire started in the late night hours when a loud hollow sound was recorded at the time of the fire, with subsequent cracking. A witness of the fire said that the sound resembled an explosion. This fact is confirmed by the CCTV record, on which is shown the sudden flare of the ship and the spread of the fire. Fire started in the middle of the ship from where it subsequently spread across flammable structures to other parts of the ship.

Figure 3 – Situation with point of origin marked.

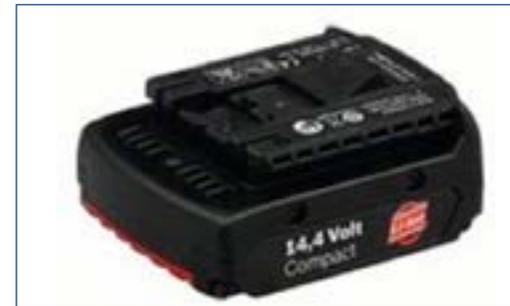
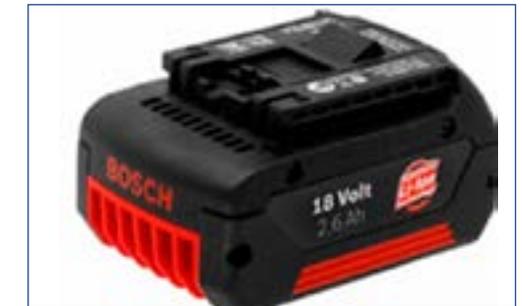
The cause of the fire was a technical fault in the Bosch 18 V, Li-Ion, 2.6 Ah battery pack (next only „AKU1“) which was stored in the Bosch AL 1860 CV stand-alone battery charger. This technical failure of AKU1 was the result of a previous non-standard use when the module inappropriately powered the OR-T 250 strapping machine with a nominal voltage of 14.4 volts with a nominal voltage of 18 V. By active strapping function (especially its EC motor) was overloading the AKU1 and thereby destroying its elements. Critical damage to one of the elements then, along with the fast-charging procedure, initiate the process of successive self-discharge of its fully charged paired cell (pairing for higher capacity).

Figures 3, 4 – Comparison of two batteries.

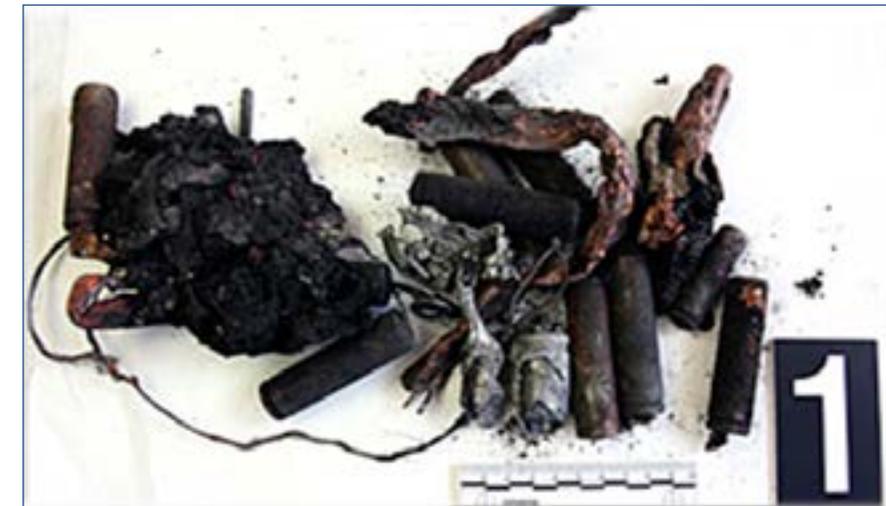
Figure 5 – Complete assembly of battery.

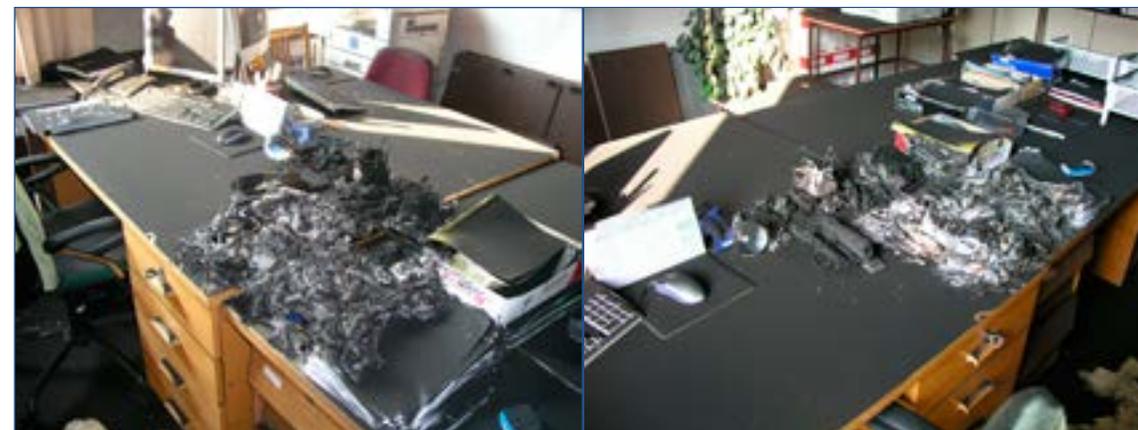
Due to the intense sunlight and the storage of flammable material (paper) in the immediate vicinity of the glass paperweight, there was a physically optic phenomenon - the focusing of the optical bundle with subsequent ignition of flammable office paper. According to the literature, two basic physical and optical conditions for the ignition of slightly flammable substances have to be met. There should be no filtering or substantial weakening of the long-wavelength of the spectrum of infrared sunlight. Rays must be bent on a sphere that separates two optical environments into one focus. The smooth clear deflected glass balls the matte surface and the scarring that the sun's rays have long passed, have fulfilled these conditions.

Figure 1 – View captured from right side.

Figure 2 – View captured from left side.

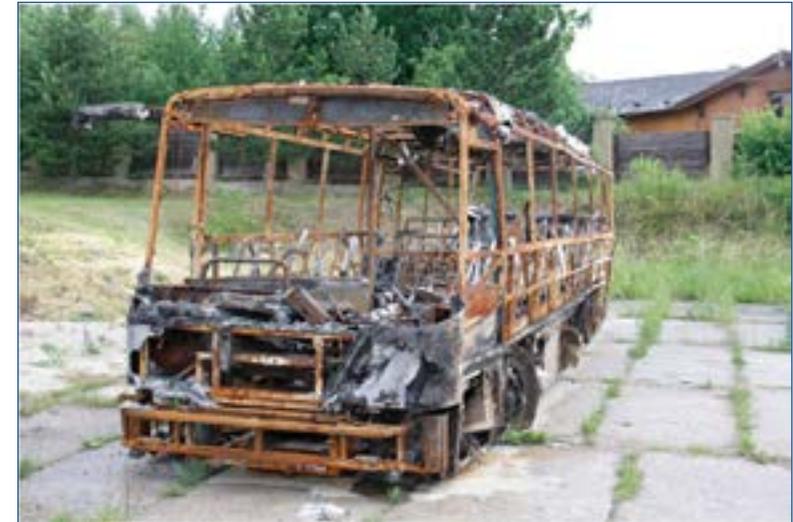
A fault on the tightness of the oil system occurred during the ride of the vehicle and it caused that the oil leaked (under pressure) out from the lubrication system. Hot surface of the exhaust pipe close to the leakage ignited the oil. The fire started to spread from the engine toward the front part of the bus. Approximately after 10 minutes the fire increased the temperature around CNG cylinders (placed on the roof of the bus) above the temperature limit.

Figure 2 – CNG bus after the fire.

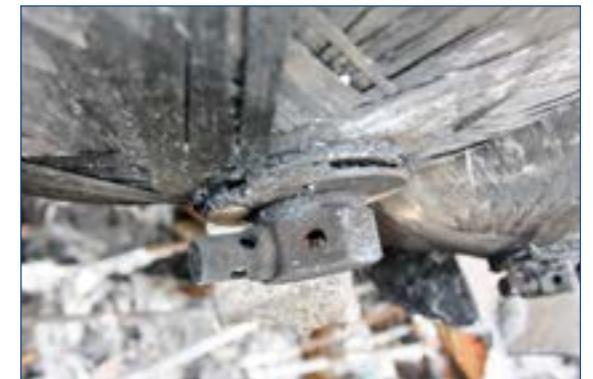
CNG multifunctional cylinder valves (with thermal fuses) responded to these conditions and controlled leakage occurred. This was reflected by upward fire jet which persisted several tens of second. Any CNG cylinders explosion did not occur. None of passengers were injured, but the bus was completely destroyed.

Figure 4 – Thermal fuse.

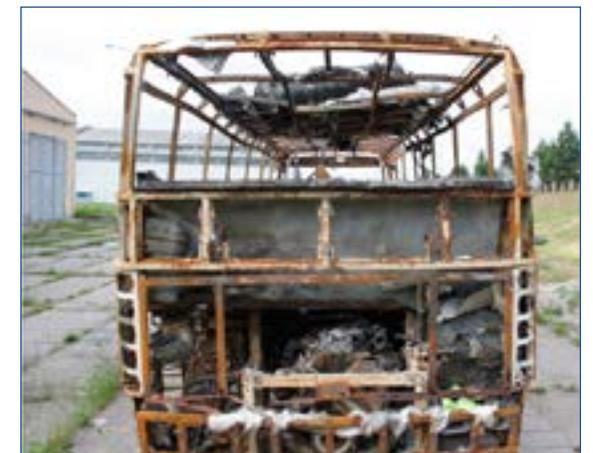
Figure 5 – The rear part of the bus - engine.

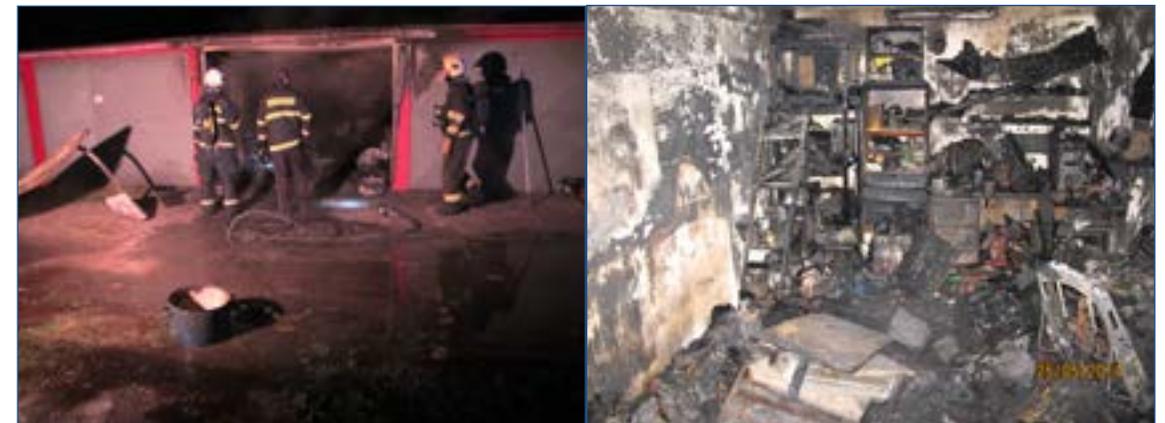
From the above was found that the garage had been used for an illegal drug production. For this purpose the chemical substances were dissolved in the pot, which was placed on an electric cooker. The heating spiral of the cooker ignited vapors of the toluene and the fire started to spread. One person was burned (second-degree burns on his hands and head).

Figure 3 – Pot used for pervitin production.

Figure 4 – Interior of the garage.

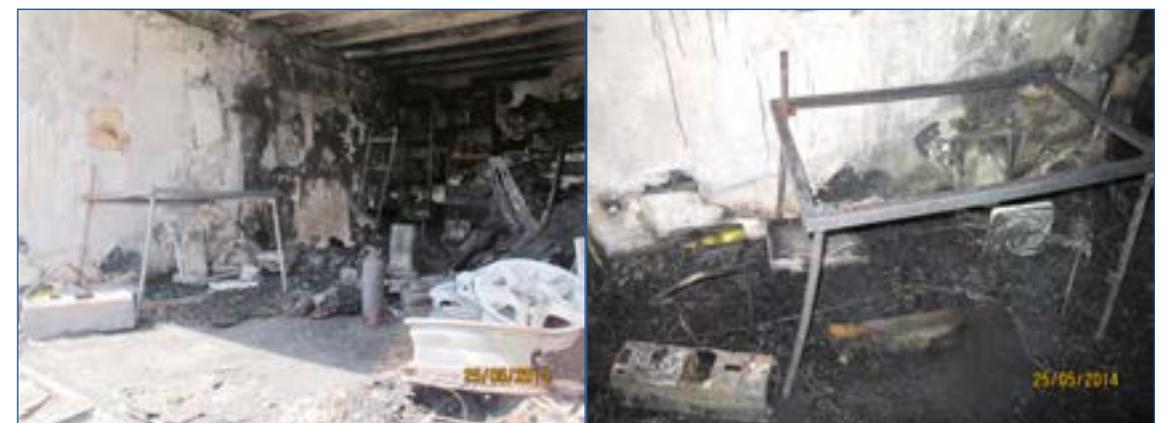
Figure 5 – Point of origin - left side.

Figure 6 – Table on which the electric cooker was placed.

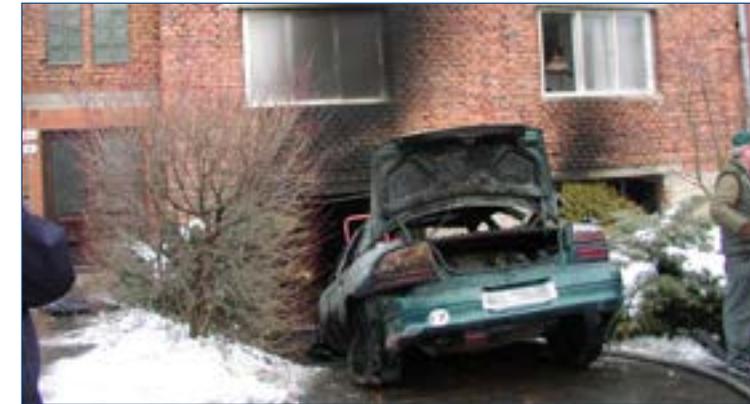
Figure 1 – House and the car after pulling out of the garage.

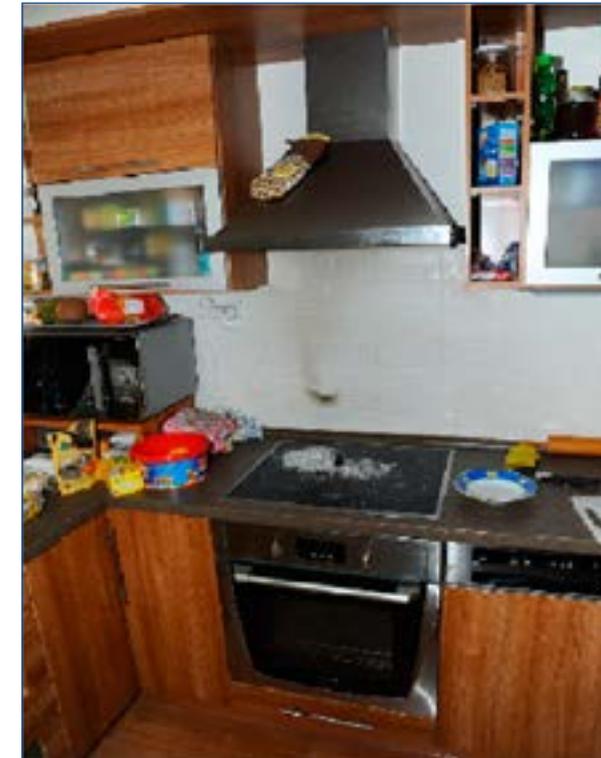
When the FRS of Capital of Prague arrived to the fire scene a smoke with acrid smell was spreading out through the entrance door of the apartment unit. Firefighters forcibly entered the entrance door and found the toaster in the fire laying on the glass-ceramic plate of kitchen stove. The on-site investigation revealed that the toaster placed on the glass ceramic plate was not plugged into an electricity source. The apartment user stated that he had left the apartment about three hours before the fire occurred. The user also said that he had been preparing breakfast in the morning and he had used a toaster only - he had not used the glass-ceramic plate. At the time of the fire, nobody was present in the apartment except a cat which could move around the apartment. Another investigation revealed that firefighters recorded the light of the ceramic plate power indicator during the fire extinguishing and the users confirmed that the cat turned on the glass-ceramic plate by jumping on it.

The investigation found that the unintentional switching on of the glass ceramic plate by the domestic animal can occur in spite of the activated child safety device, which the animal turns off first with its movement.

Figure 1 - The glass ceramic plate in the kitchen unit.

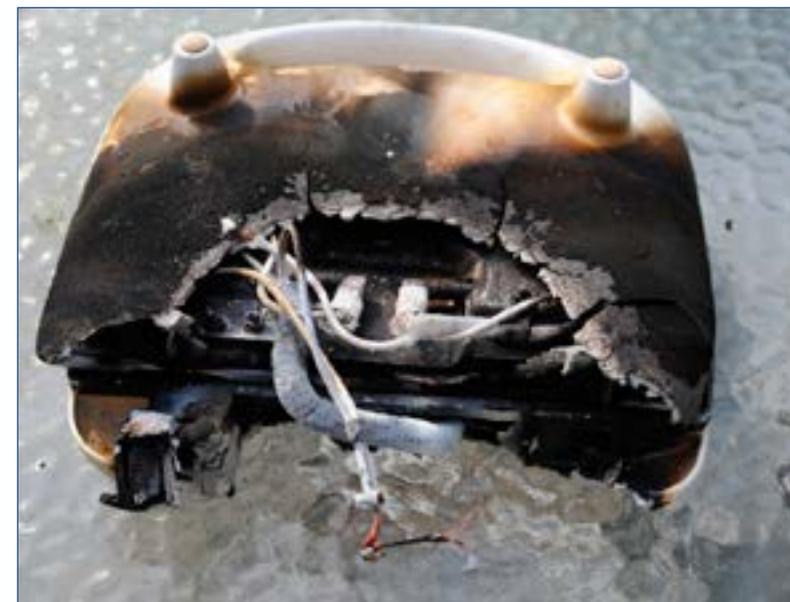
Figure 2 - The toaster.

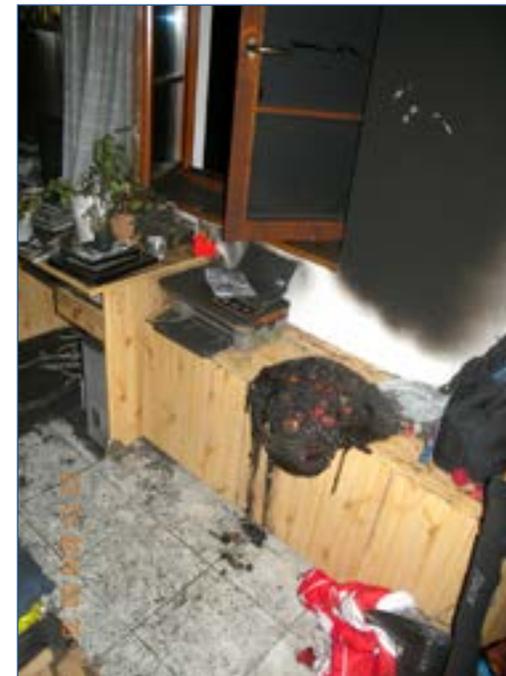
Cause of fire: manufacturing defect of the fruit dryer.

Figure 1 - Overall view of the fire scene in utility room of family house.

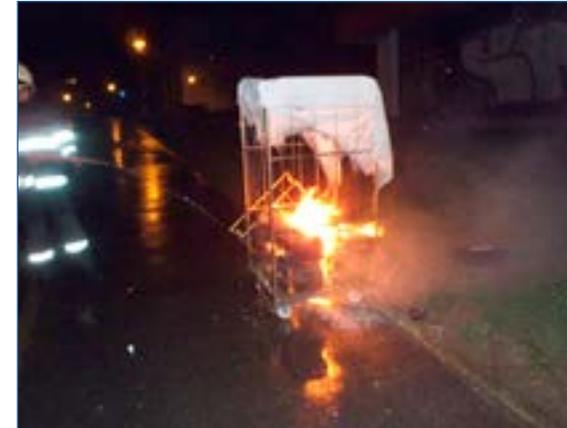
Figure 1 - Burning laundry cage.

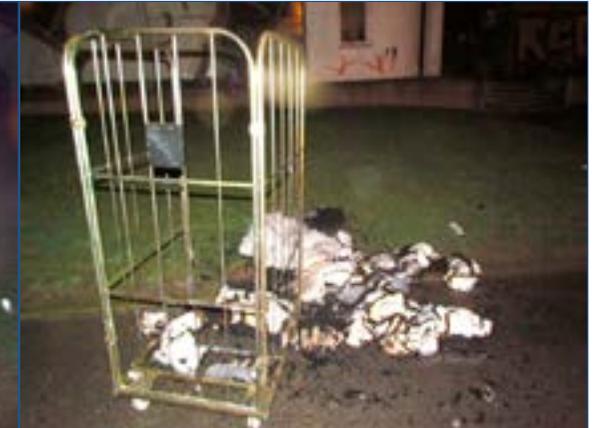
Cause of fire: chemical auto-ignition.

Figure 2 - Laundry cage after extinguishing.

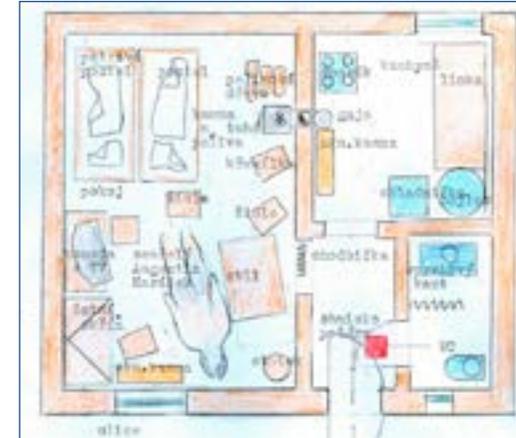
Figure 1 - Floor plan of the house.

The first sign of the fire (changing colors of windows glasses caused by soot) was noticed by a neighbor, but she just thought the user had new blinds installed. And because she also noticed lights in the house and radio voice coming from the house, she did not pay attention to this sign. Next day the house owner came to visit the user. When she unlocked the entrance she smelled smoke and found dead user lying on the floor. She also found burned stuff in front of the toilet door which later the fire investigator identified as the vacuum cleaner with accessories and an original packaging - the cardboard boxes.
